Published August 26th, 2015

## Creek Culverts: The Weakest Links of the Moraga Storm Drain System

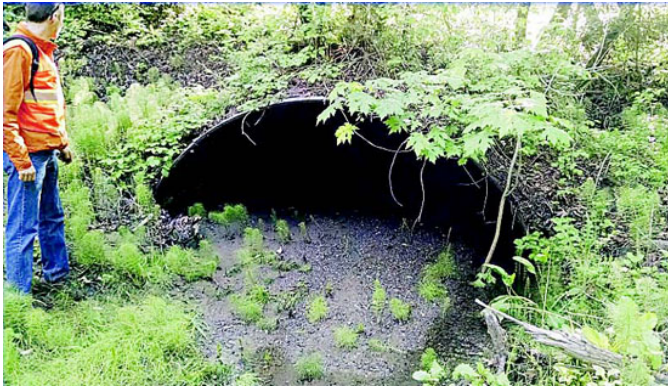
Las Trampas Creek crossing at Bollinger Canyon Road Photo provided

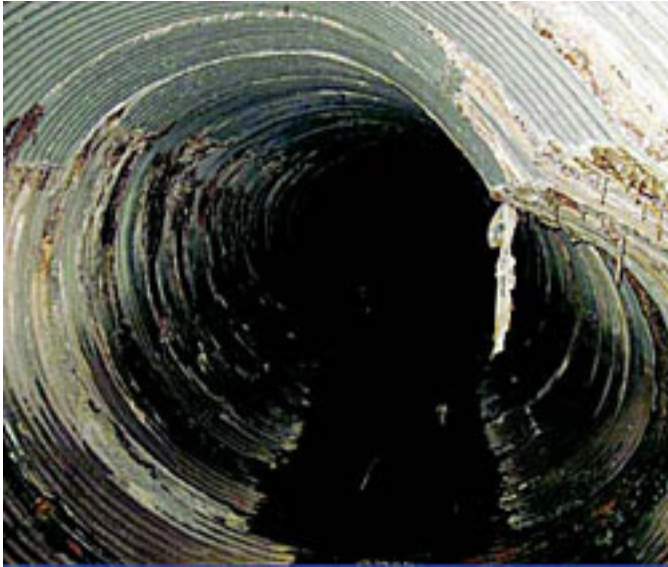
Rheem Shopping Center culvert for Laguna Creek Images provided

including it as part of the pavement project. The highest of all priorities as far as repairs are concerned is the large 8-foot diameter Rheem Center culvert that conveys water from Laguna Creek. It runs under a privately owned parcel, and it is unclear if a public drainage easement exists.
